Investigation of the corrosion cracks in a C4 heavy transport pipeline by microscopy, fluorescence and diffraction techniques

The study presents the results of a research performed in order to establish the conditions that lead to the corrosion of a transport pipeline for C4 heavy fraction.

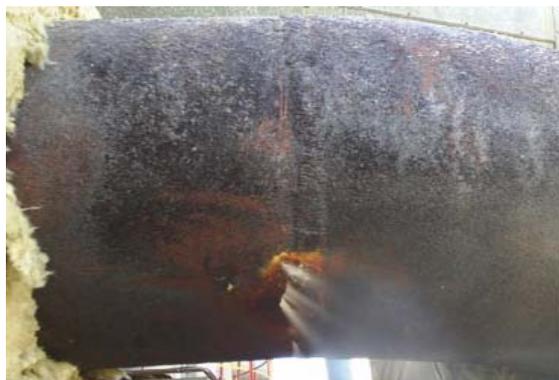
The 100 mm crack was situated next to a welding joint, which was connected to an elbow fitting (Fig. 1). After opening the pipe, a gelatinous mass, which covered approximately 40% of the lower interior part of the pipe, was observed (Fig. 2).

Fig. 1. Detail view of the area in which the product pipeline cracked

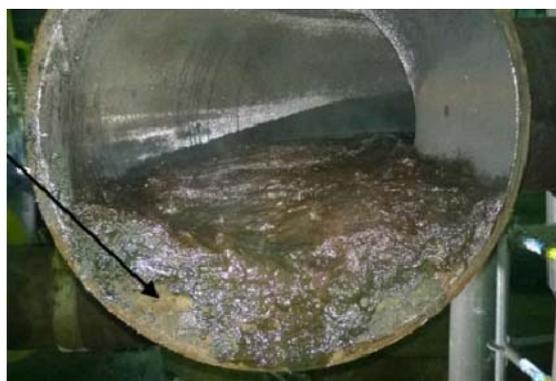
Fig. 2. The appearance of the interior of the pipe after opening

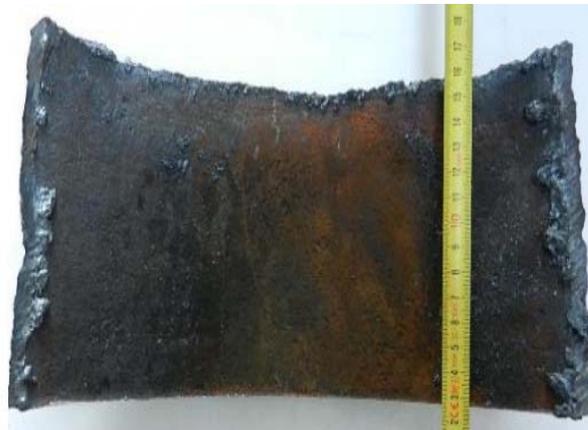
The general aspect of the pipe was deemed technically normal. On the exterior side it showed a thin layer of oxide without any unacceptable imperfections. On the interior, the surface showed general signs of corrosion in points of low intensity (Fig. 3).

Fig. 3. Interior surface of the pipe in the cracked area

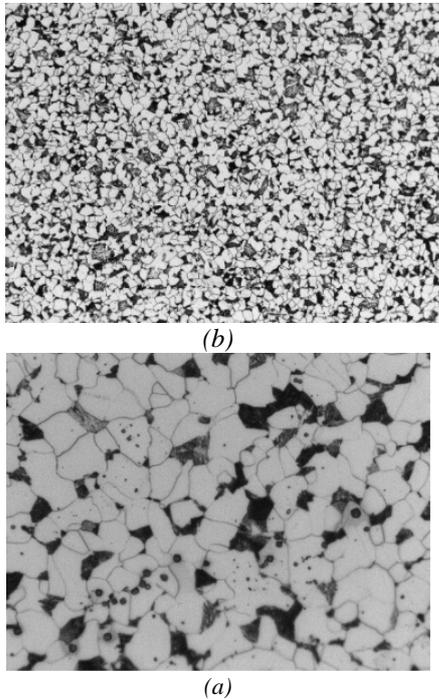
Fig. 4. The microstructure of the pipe material. Attack with NITAL 2%. a) $\times 100$; $\times 500$

The material microstructure consists of ferrite and pearlite with rare areas of overheating structure. These are typical characteristics of the microstructure of a carbon steel in hot rolled condition. ASTM A 53 specifies that pipes must be made by hot rolling, followed by cold calibration in order to ensure employment in shape, dimensions and properties included in the standard.

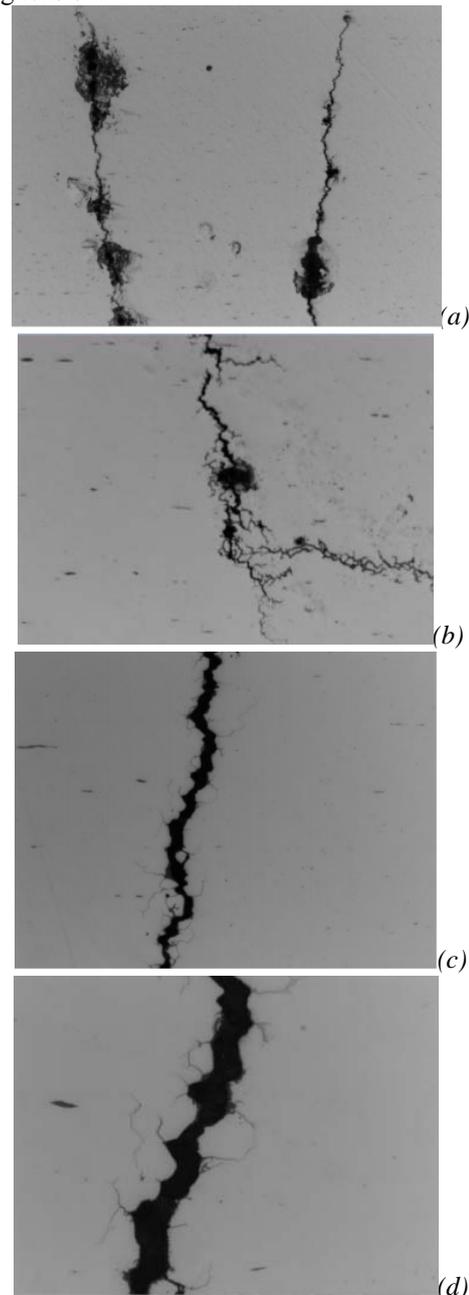
- un-attacked, the pipe wall section appears pierced by fissures mainly oriented towards the thickness direction. The main crack fronts show a tendency to branch out towards smaller fronts nearby (Figure 5)

Fig. 5. Un-attacked sample. Cracks in the direction of pipe wall thickness. a, b, c - the sample surface area examined in thickness $\times 200$; c area at $\times 500$

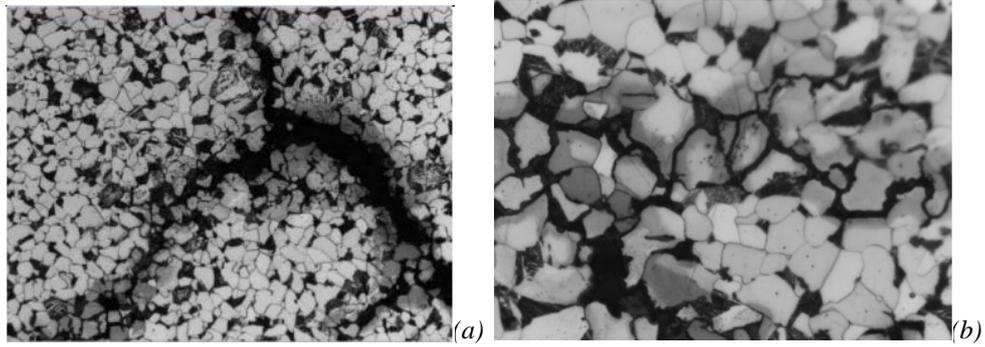
- after the metallographic attack (Figure 6), the cracking character is obvious, namely to corrosion cracking tension.

Fig. 6. Sample attacked with NITAL 2%. Details of the cracked areas. a) $\times 200$; b) $\times 500$

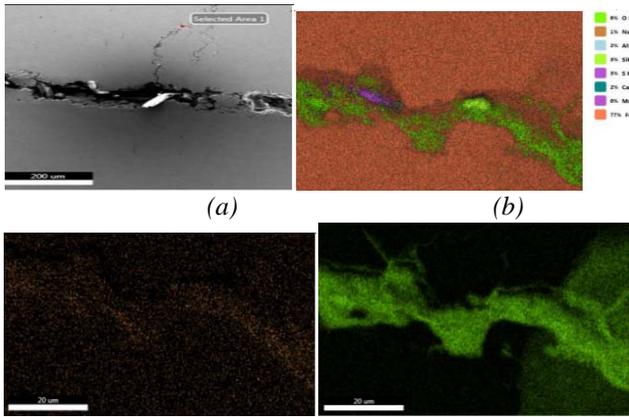
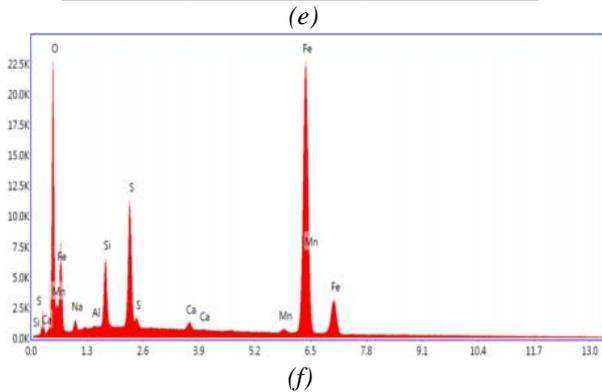
Element	Weight %	Atomic %
OK	27,18	52,12
NaK	3,65	4,87
AlK	0,12	0,13
SiK	3,65	3,99
SK	6,86	6,57
CaK	0,6	0,46
MnK	0,6	0,33
FeK	57,33	31,50

Fig. 7. Image analysis of an area in the crack. a) analyzed area; b) distribution section of various elements; c) the distribution sodium; d) the distribution of oxygen; e) table with elements identified in the spectrogram; f) the spectrogram

- The chemical environment present at crack tips was rich in oxygen, sodium and sulfur;

- Around the finest peaks of the cracks, the presence of an oxygen rich aggressive environment is particularly noticeable.

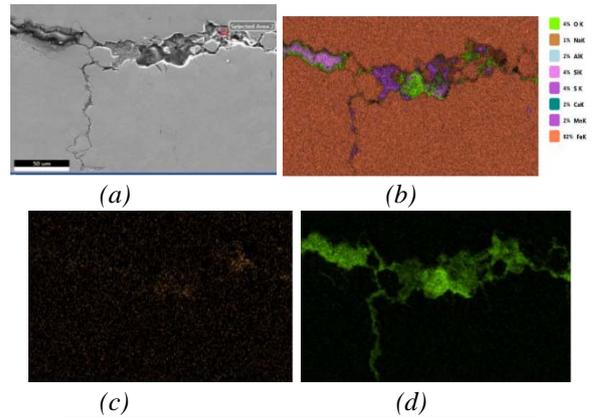
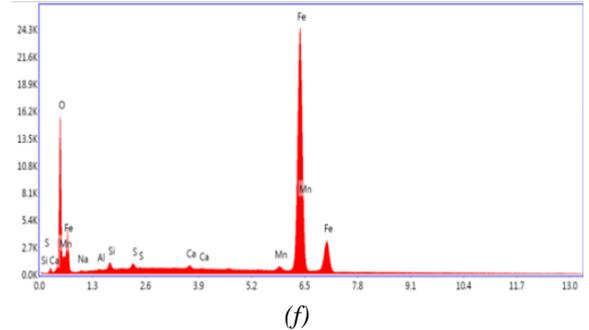
Element	Weight %	Atomic %
OK	20,06	46,30
NaK	0,47	0,76
AlK	0,01	0,01
SiK	0,29	0,38
SK	0,20	0,23
CaK	0,30	0,27
MnK	1,15	0,77
FeK	77,52	51,26

Fig. 8. Image analysis of a secondary area in the crack. a) analyzed area; b) distribution section of various elements; c) the distribution sodium; d) the distribution of oxygen; e) table with elements identified in the spectrogram; f) the spectrogram.

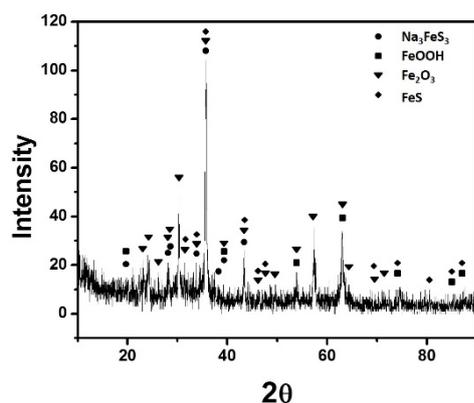
The deposition was also analyzed by X-ray diffraction technique and the nature and proportions of the compounds identified are presented in Fig. 9.

Fig. 9. X-Ray diffraction analysis of the deposition

In the process, the pipeline operated at 85°C and a pressure of 9 bar. In the area of the incident, a relatively consistent deposit was formed inside the pipeline.. Compared to the normal operation of the pipeline, the deposit represents a foreign body. The analysis presented in this report shows that the nature of the deposition compounds indicates high contents of Na, O and S, with a strong basic pH index.

Analysis of the deposit was performed by X-ray fluorescence and showed significant contents of Na and S, and the X-ray diffraction analysis revealed compounds rich in Na and S. The deposition, totally void of organic products, indicated a strongly basic pH with a value of 12.
